Subject: Department of Natural Resources Washington Geological Survey,
School Seismic Safety Assessment Project, Contract No. AE 410 -
Seismic Evaluation for **East Valley (Yakima) School District**

School Buildings Evaluated in the East Valley (Yakima) School District

Table 1-3. Identified Structural Seismic Deficiencies for East Valley (Yakima) East Valley Central Middle School 6th Grade Building

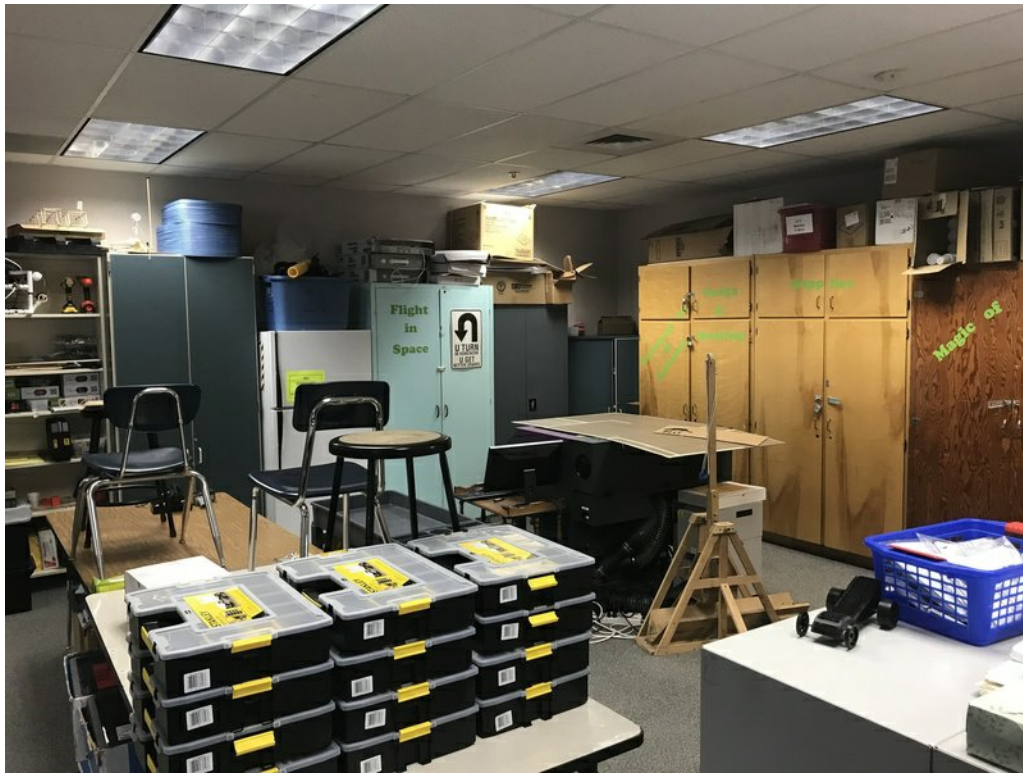
Figure 1-6. Classroom 404 with Unknown Light Fixture Bracing, Typical Throughout Building

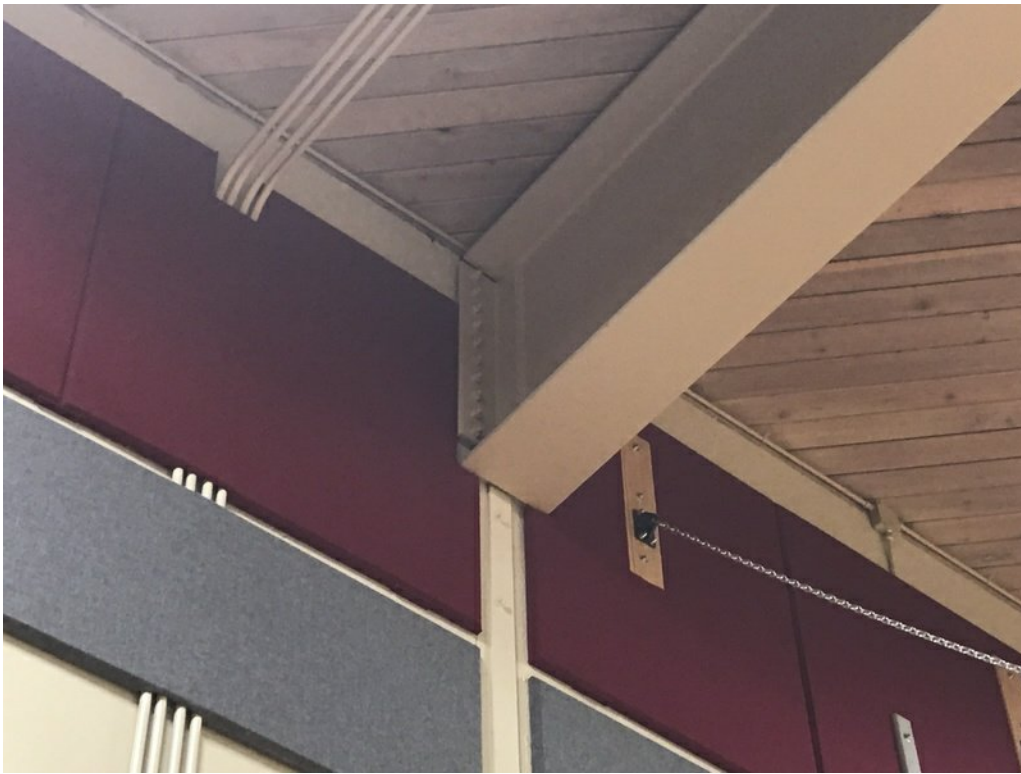
Figure 1-6. Commons with Unknown Light Fixture Bracing

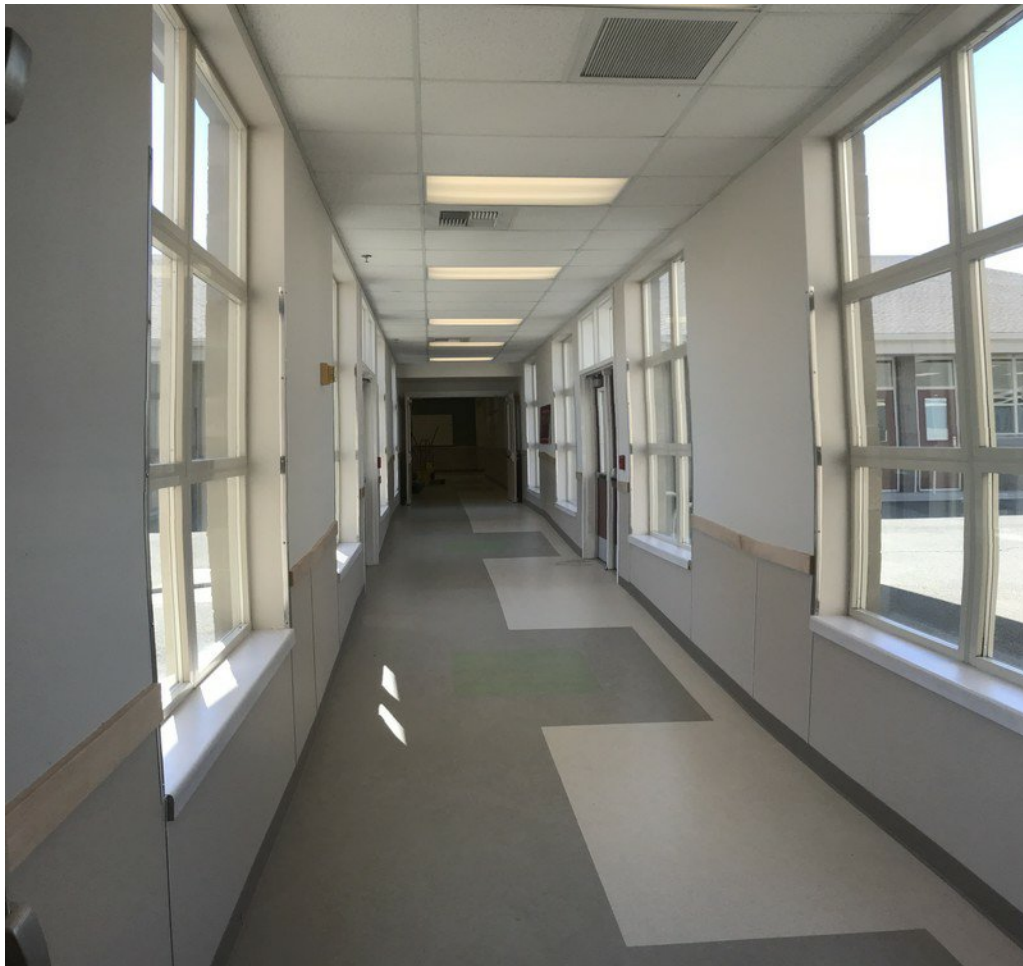
Figure 1-5. Interior of Hallway Between Wings. Unknown Light Fixture Bracing and Lack of Seismic Joint Between Buildings, Typical.

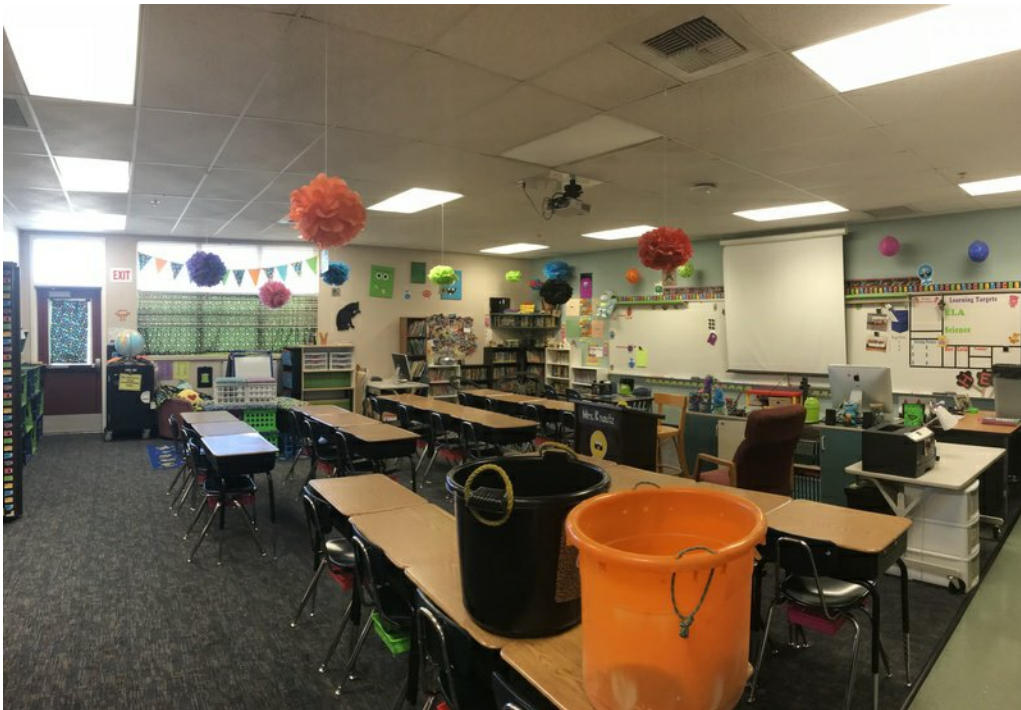
Figure 1-6. Classroom with Inadequate Fire Sprinkler Head Penetration Clearances, Typical

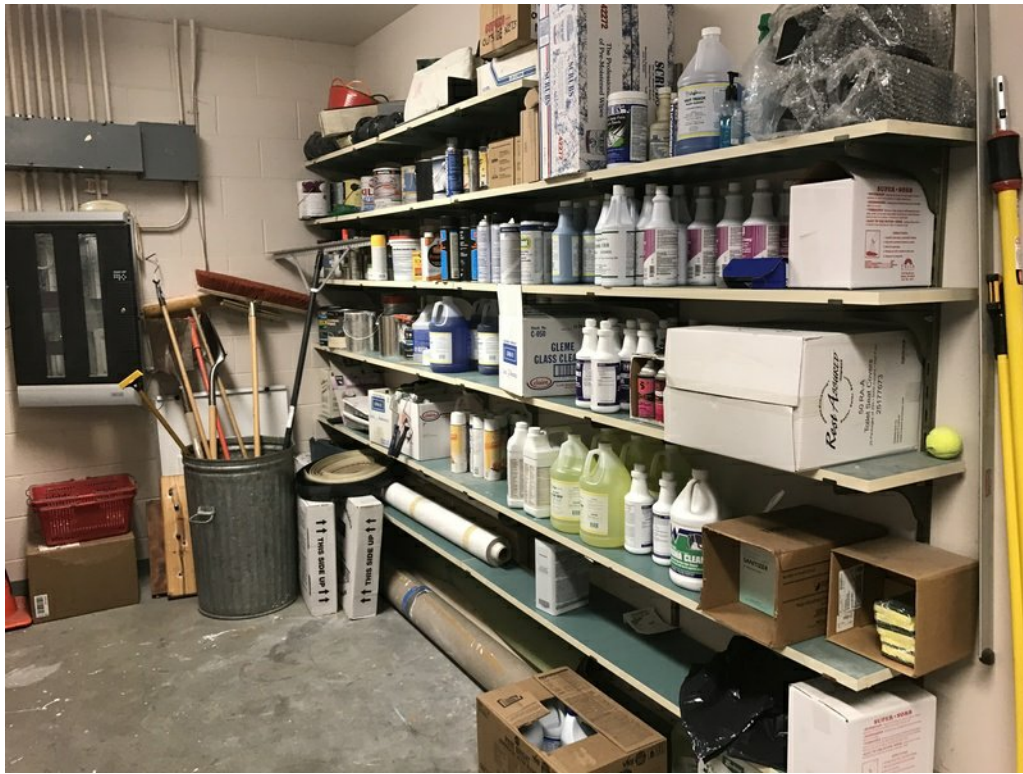
Figure 1-10. Unrestrained Hazardous Material Storage
